# PROPERTY INSPECTION REPORT

**Prepared For:** Sample Client  
(Name of Client)

**Concerning:** 1234 Sample Address, Somewhere, Texas 76000  
(Address or Other Identification of Inspected Property)

**By:** Tod Brooks TREC # 9842 02/22/08  
(Name and License Number of Inspector) (Date)

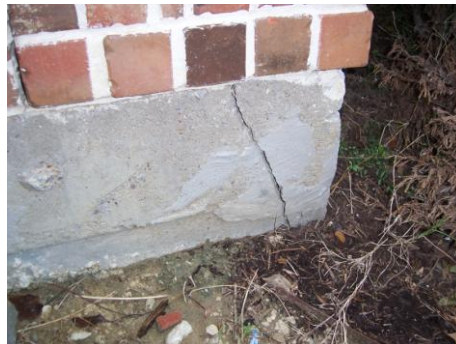
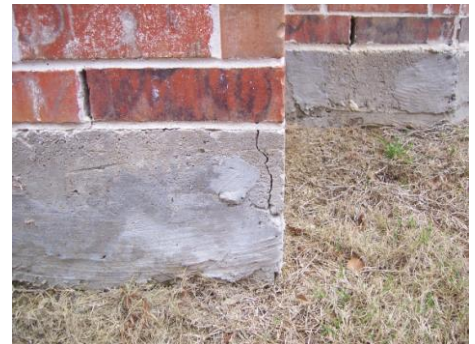
At the front left and right rear corners of the house, the foundation wall has cracks in it, but has not broken completely off. It is not significant at this time, however it should be monitored. It is recommended to patch with some type of concrete caulking to not allow water to penetrate the cracks and worsen. If this condition were to worsen, it could lead to instability of the brickwork. If movement occurs, re-supporting of the brick would be advisable.

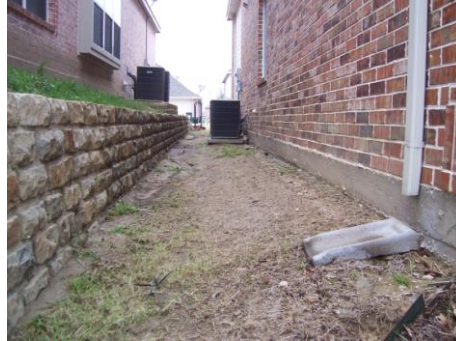
The left side of the house has plenty of brick veneer to soil clearance, and the slope away from the house is about as good as can be due to the adjacent house on the left being on a higher lot. There is a rock retaining wall that separates the two lots, which also minimizes the amount of effort or changes that can be made.

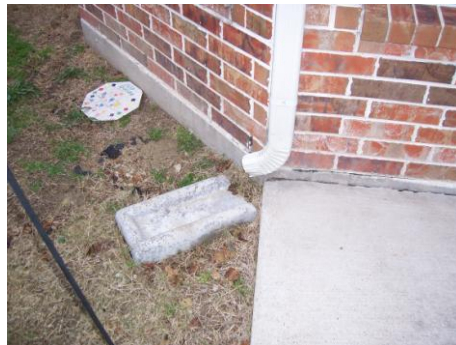
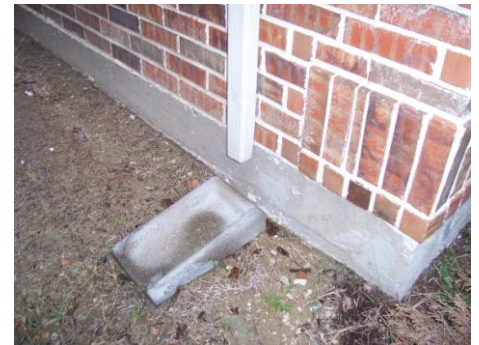
All gutter downspouts should discharge at least 3 feet away from the foundation so that excessive water is not allowed to stand or pond near the foundation. All storm water should be encouraged to flow away from the structure at the points of discharge. Below is only a representation of the gutter downspouts. Also, the concrete water diverters should be turned to allow the water to run away from the structure. Several are turned backwards and are sloped toward the foundation.

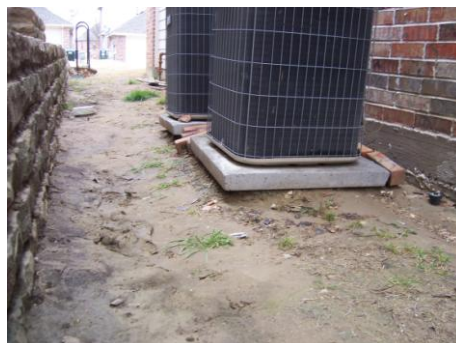
The air conditioning units on the left side of the exterior of the house should have the pads that they sit on leveled and dirt filled in underneath them. If the soil continues to erode away, then the air units could become unstable and cause worse damage. Simply make sure that they sit level and that there is dirt under the pad they sit on.

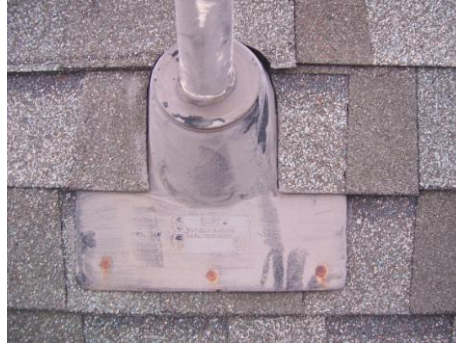
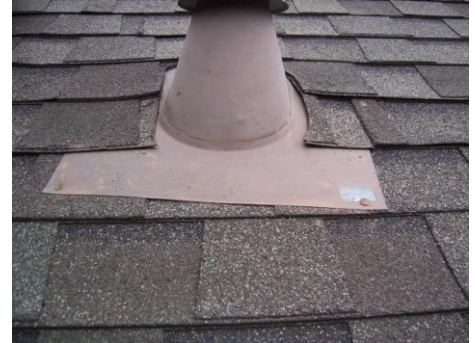
There are exposed nail heads at most, if not all, roof flashings. This nail heads should be caulked with clear silicone to avoid rusting and allowing the nail head to pop off and potentially allow the flashing to not be secured to the roof.

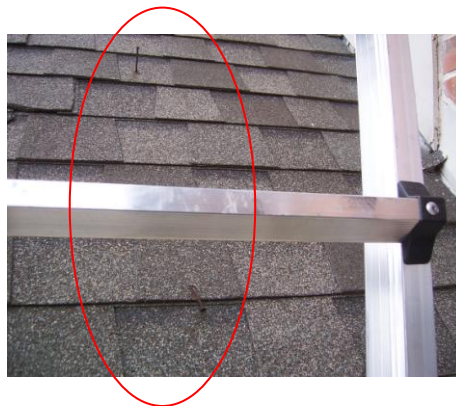
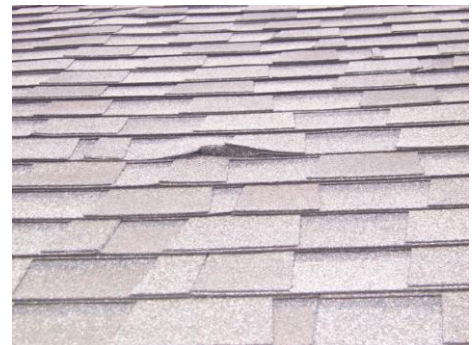
There are several nails in the roof covering at the back of the house above the back door area, unknown as to why. They should be removed and caulked to not allow water penetration. Also, at the back of the house, there is a shingle that has turned under. It appears to somehow been folded back under. It should be straighten out and checked to see how damaged it may or may not be.

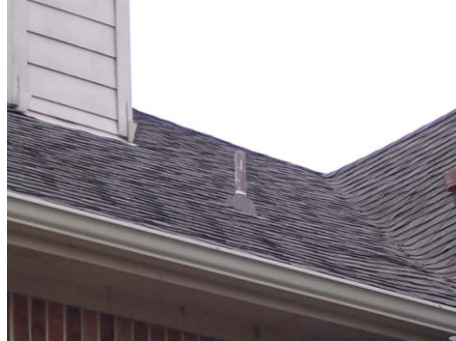
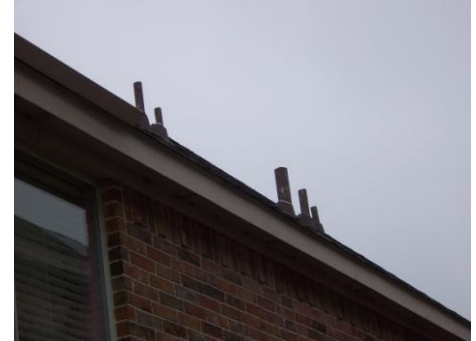
The pvc roof vents should be painted to help protect them from the UV sunlight, which can cause them to weather faster and become brittle and break. They appears to have been painted originally, but it is faded and wearing off. This is a maintenance issue, and not an immediate repair.

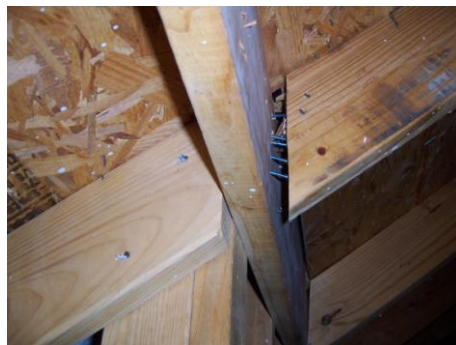
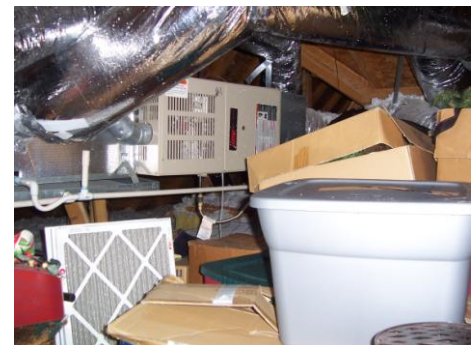
The roof structure is of rafter type construction, and appears to be in satisfactory condition on the day and time of the inspection. Only one rafter was noticed to be pulled away from the purlin. This should be reinforced.

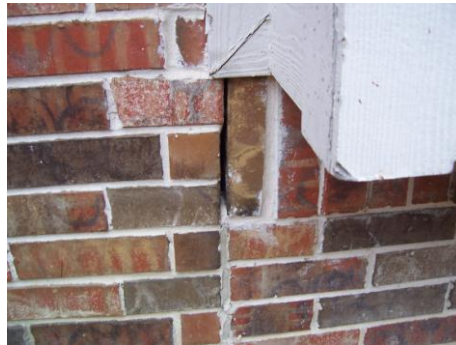
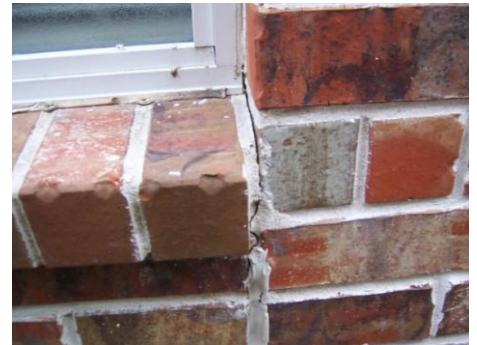
There are several stress cracks found in the brick veneer. This is typical and does not pose a significant structural problem. If the cracks get bigger or open up more, then sealing those areas will be important. As well, you will want to continually monitor those areas in the future.

The expansion joint on the right side of the house at the kitchen bay window needs to be caulked. Also, any other stress cracks or separation in the brick veneer should be caulked to not allow moisture penetration. Especially at window ledges, where moisture could get in behind the wall and into the interior.

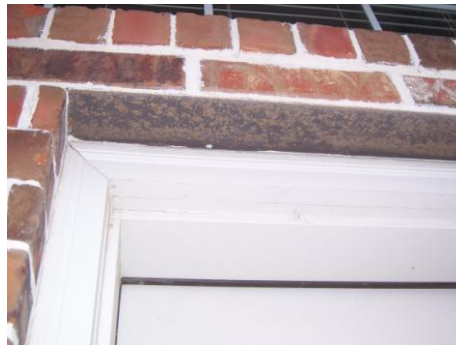
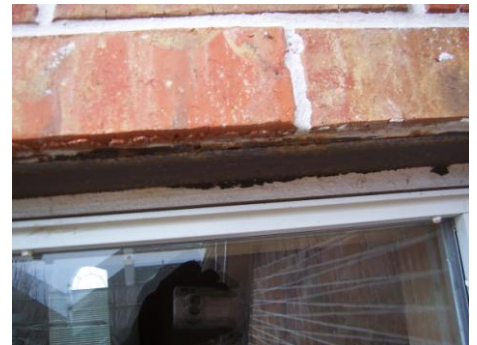
The lintels (metal angle iron) above all windows and exterior doors used to support and hold up the brick veneer above are showing signs of rust. Recommend regular priming and painting of these lintels so that extensive rusting does not occur.

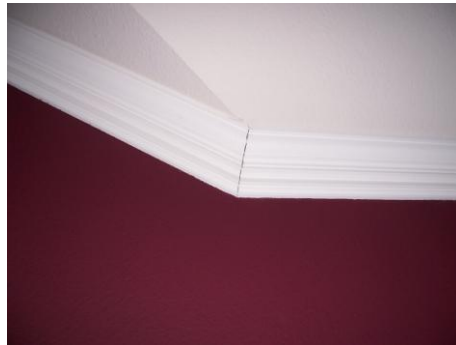
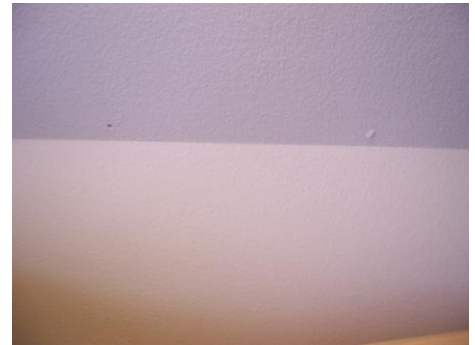
There were a few settlement cracks found in the interior, primarily in the crown molding and a few drywall nail pops. Below is only a representative sampling of the cracks and nail pops. The drywall nail pops were in the front living and dining area and in the upstairs boy's room.

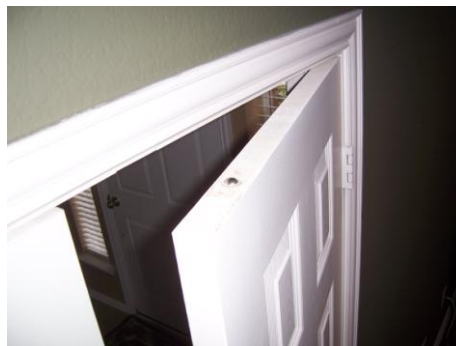
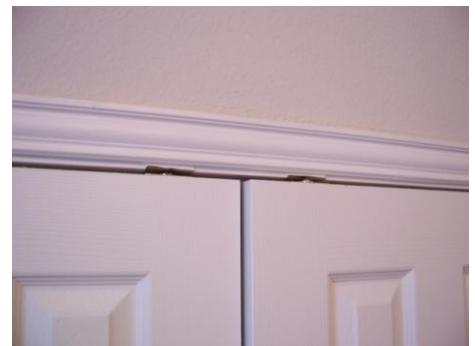
All interior doors were found to be in satisfactory condition on the day and time of the inspection. However, several of the twin closet doors (in the study, in the first bedroom on the left as you get to the top of the stairs, and the pink girls room) do not stay closed because of the ball catch at the top of the door. They simply need adjusting.

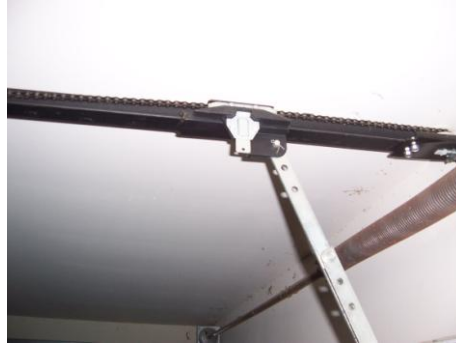
The garage door does not have a release rope attached to disconnect the door from the opener.

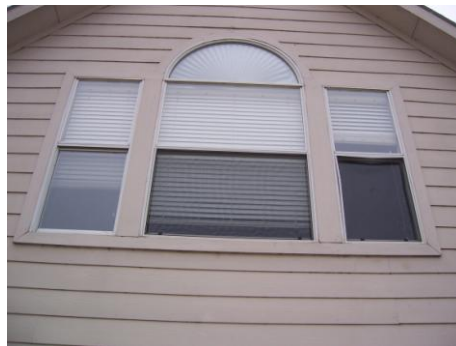
The only screens of concern were on the large double window at the upstairs game room over the garage. One was removed and on the inside, and the other was slightly bent and damaged.

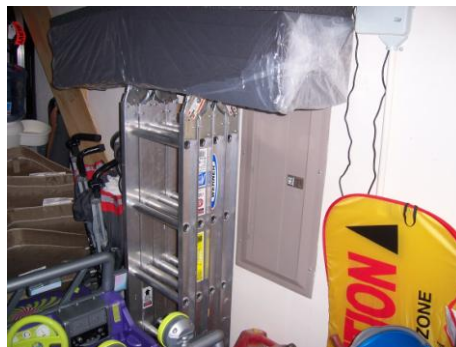
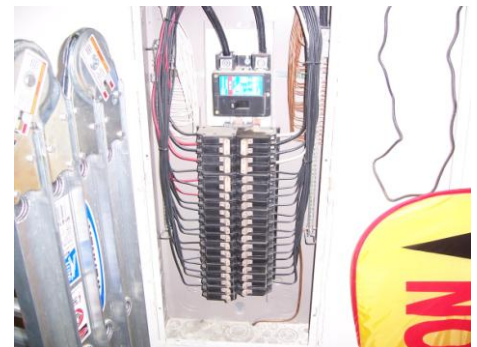
The main service wires come in underground and to the panel box located in the garage. The main electrical panel is located in the garage and contains the main shutoff breaker and also houses the subpanel for all branch circuits. The panel box is rated for up to a 225 amp service, and it currently has a 200 amp main breaker installed. That is ok.

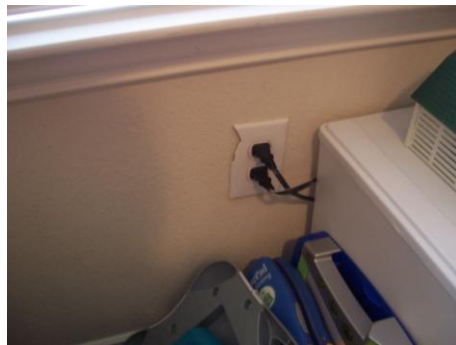
There was one broken receptacle cover plate in the first bedroom on the left at the top of the stairs.

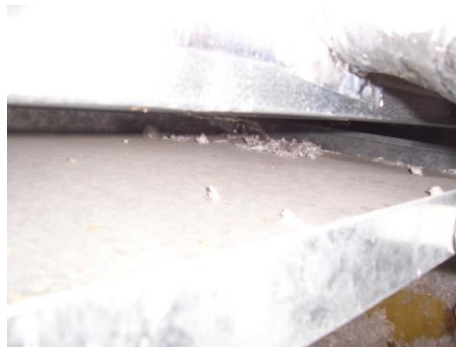
The secondary drain pans mounted underneath the air handlers in the attic need to make sure that any debris is cleaned out. In the event of a stopped up primary drain line, then the secondary would drain into the pan and out the drain line. Any debris in the pan could clog up that line as well.

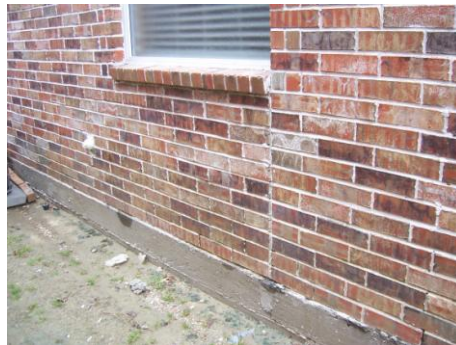
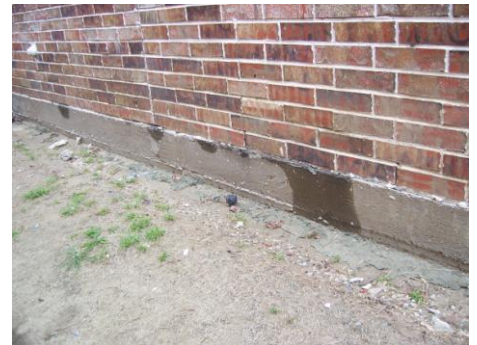
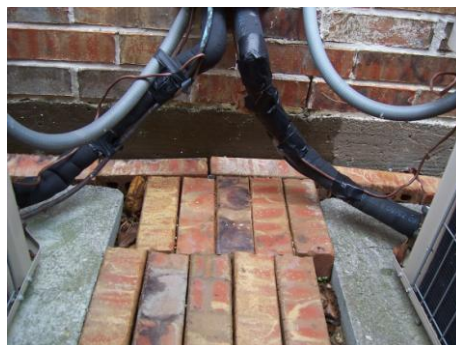
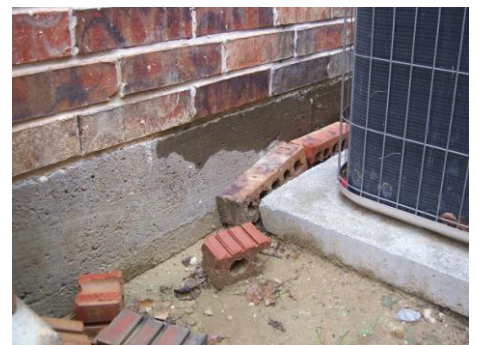
All components were found to be in satisfactory condition on the day and time of the inspection, with the exception of the master shower. It appears that there is some type of leak at or under the shower base/pan. Considerable moisture was observed on the exterior wall at the brick veneer and slab joint line. I ran the tub and shower extensively, and it appears to be isolated to the shower.

**It is recommended that a licensed Plumbing specialist be contacted for further investigation as to the cause and solution of this issue prior to closing.**

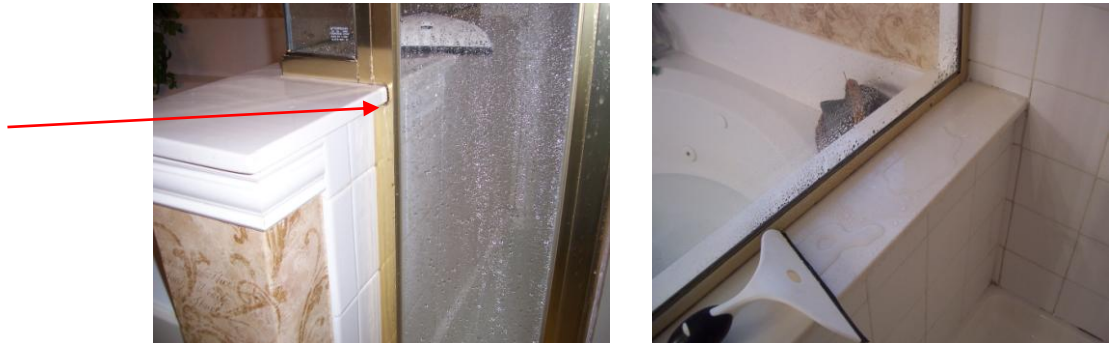
Also, related to the master bath shower, there is a slight leak at the front left corner trim area that meets the marble, and water stands on the marble ledge.

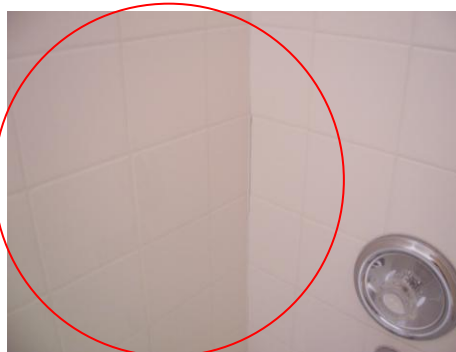
The upstairs bathroom tub/shower ceramic tile surround need to be caulked at all corners to not allow moisture to penetrate.

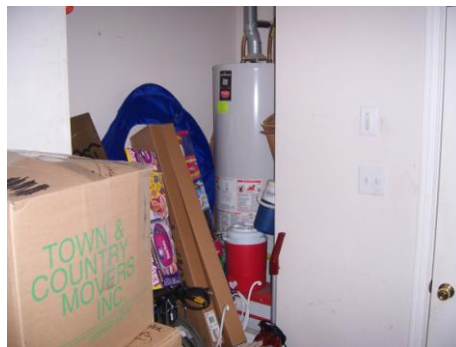
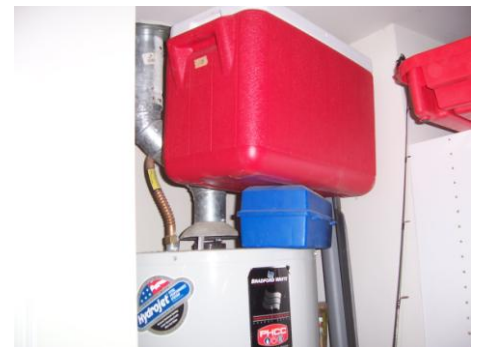
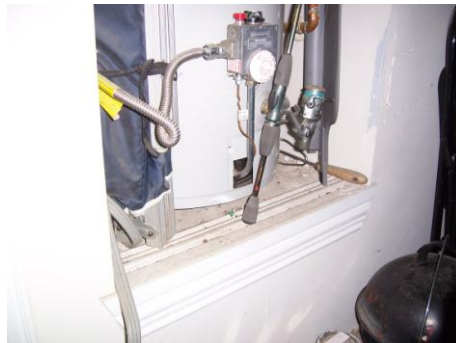
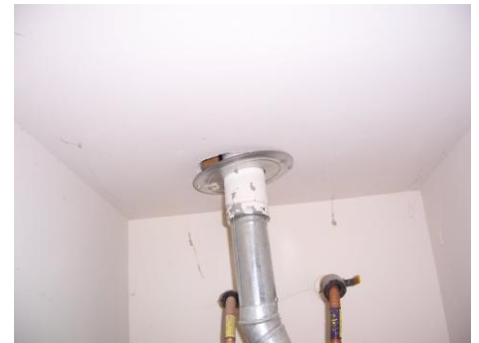
There were (2) 50-gallon gas water heaters located in the garage. Both do not have emergency drain pans installed. This was typical of the time frame the house was constructed. However, they do not meet today's standard for that. Also, make sure that the area around the water heaters remains clear for safety reasons and to allow the gas draft hood to vent properly. At the ceiling on one unit, the draft vent pipe cover is loose and hanging down. This should simply be secured to the ceiling to cover the hole.
